Multi-Media Compliance Evaluation Inspection
USEPA Region III
Office of Enforcement, Compliance, and Environmental Justice

Pentagon Reservation
United States Department of Defense
425 Old Jefferson Davis Highway
Arlington, Virginia 22202

Inspection Dates: May 10, 2010 to May 12, 2010

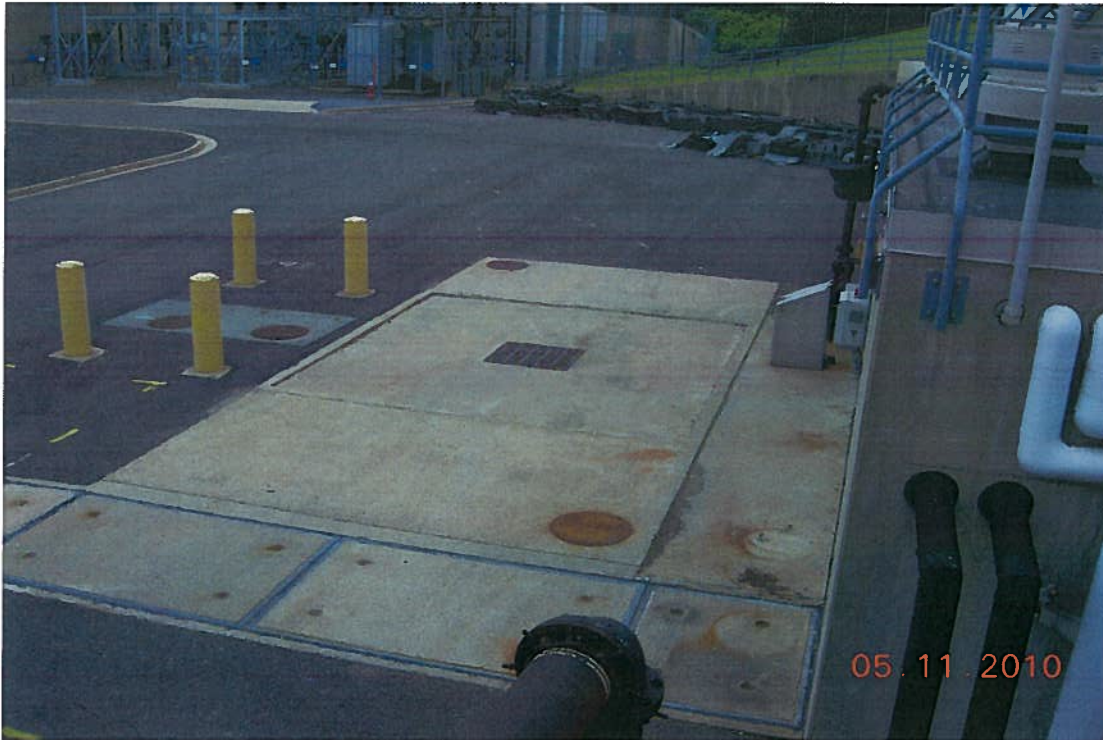
Photo No. SPCC 1 – View of HRP Unloading Area

At the time of the inspection, no warning signs were observed at the area. Mr. Siddiqui was asked about the measures followed when unloading fuel and two measures were mentioned: the correct valve is opened to allow the fuel to be stored in the appropriate tank and the tank truck engine is shut off by the driver. The unloading containment area was observed and the berm is approximately 3 inches high, see Photo No. SPCC 1. An oil/water separator was observed in the unloading area, according to the draft plan, the capacity of this oil/water separator is 65 gallons. In case of release, the oil is pumped out and the water is sent to sanitary sewer.

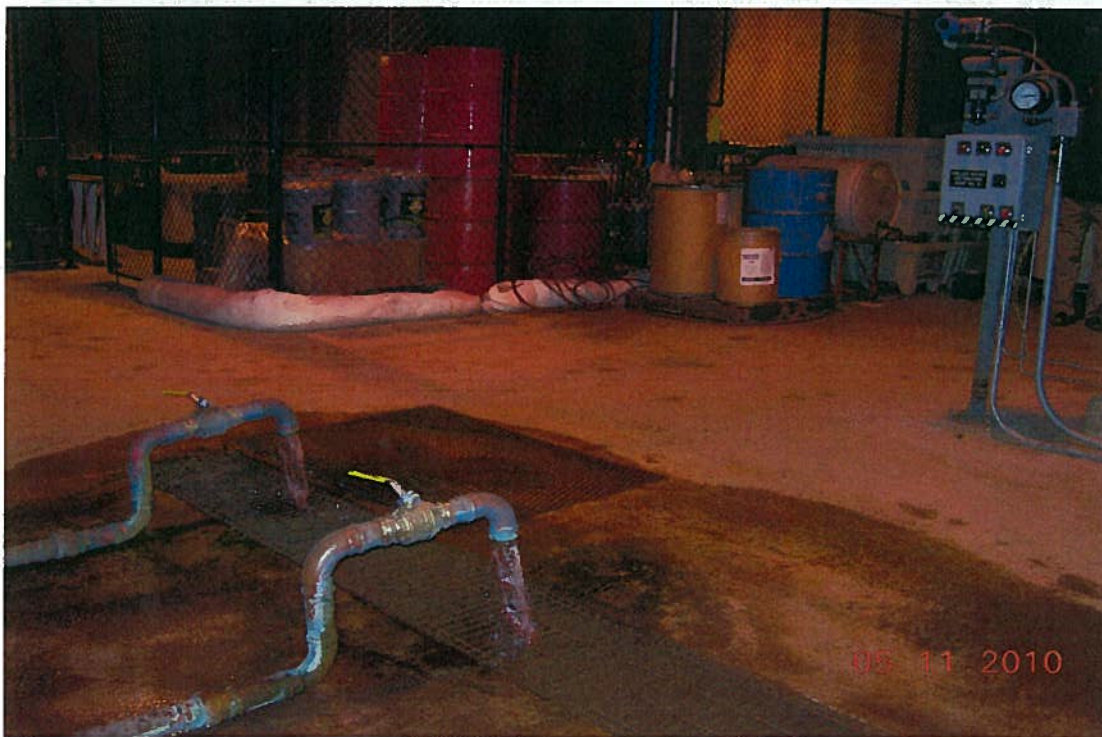
Photo SPCC No. 2 – View of PHRP Basement HS Storage

From this area, we went to the Chiller Plant. At the basement, the team observed approximately 35 55-gallon drums. These drums contained oil and used oil, based on the labels. Two of the used oil 55-gallon drums were opened and were not labeled by the Facility. Another drum was opened but appears to be new oil. This storage area is known, in the draft SPCC plan, as the HRP Basement HS Storage, with 30 55-gallon containers of new and used oil, see Photos No. SPCC 2-3. The area is next to a floor drain that is connected to a sanitary sewer system. A used lead-battery was observed on the floor, with no labels, see Photo No. SPCC 6. Two 55-gallon containers containing oil were opened at the time of the inspection, see Photos No. SPCC 4 and 5. According to Mr. Susarla, tank training will be offered on May 18 and 19. No evidence of previous tank training sessions conducted at the Facility.
